## **06/02/83 Air Canada**

Report Number	NTSB/AAR-86/02
Access Number	PB86-910402
Report Title	Air Canada Flight 797, McDonnell Douglas DC-9-32, C-FTLU, Greater Cincinnati International Airport, Covington, Kentucky, June 2, 1983 (Supersedes NTSB/AAR-84/09)
Report Date	January 31, 1986
Organization Name	National Transportation Safety Board Bureau of Accident Investigation Washington, D.C. 20594
WUN	3751-G
Sponsor Name	NATIONAL TRANSPORTATION SAFETY BOARD Washington, D. C. 20594
Report Type	Aircraft Accident Report June 2, 1983
Distribution Status	This document is available to the public through the National Technical Information Service Springfield, Virginia 22161
Report Class	UNCLASSIFIED
Pg Class	UNCLASSIFIED
Pages	116
Keywords	Air carrier, DC-9, lavatory fire, electrical arcing, source of ignition, combustible materials, emergency descent, flashfire, evacuation procedures.
Abstract	<p>On June 2, 1983, Air Canada Flight 797, a McDonnell Douglas DC-9-32, of Canadian Registry C-FTLU, was a regularly scheduled international passenger flight from Dallas, Texas, to Montreal, Quebec, Canada, with an en route stop at Toronto, Ontario, Canada. The flight left Dallas with 5 crewmembers an

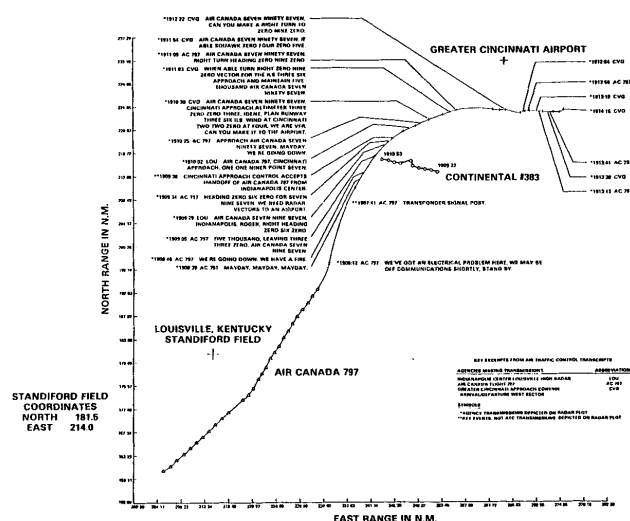
**Figure 13.--Ground radar tracks for Flights 797 and 383.**

Data Analysis Reduction Tool (DART) radar data information was obtained from the Indianapolis ARTCC. The data included airplane position information and available mode C altitude information for Flight 797 and for Continental Airlines Flight 383, which was transmitting on code 0662. The Safety Board's laboratory reconstructed the ground radar tracks of both Flights 797 and 383. Runways 9R-27L and 18-36 of the Greater Cincinnati Airport were digitized and plotted with the ground tracks. Times of key transmissions and selected key events were included along Flight 797's radar ground track. The last radar fix retrieved from the DART's data occurred at 1914:15, and the last transponder information from Flight 797 was received at 1906:12. ([See figure 13.](#))
